HOUSE DAMAGE ASSESSMENT

URS Research Company

Defense Nuclear Agency

June 1972

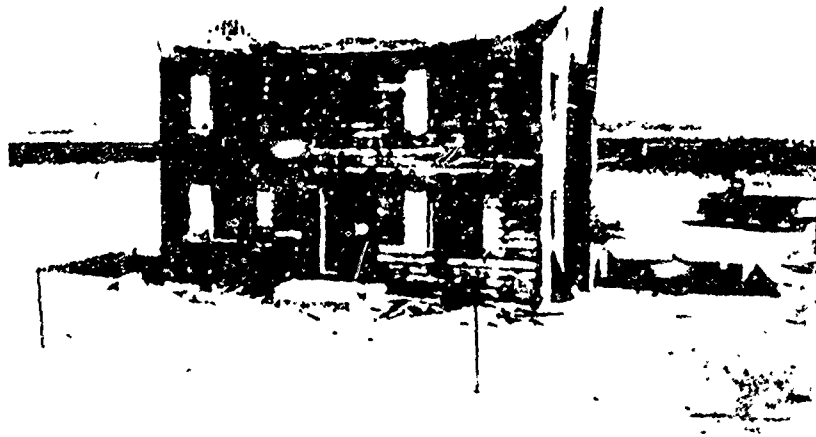
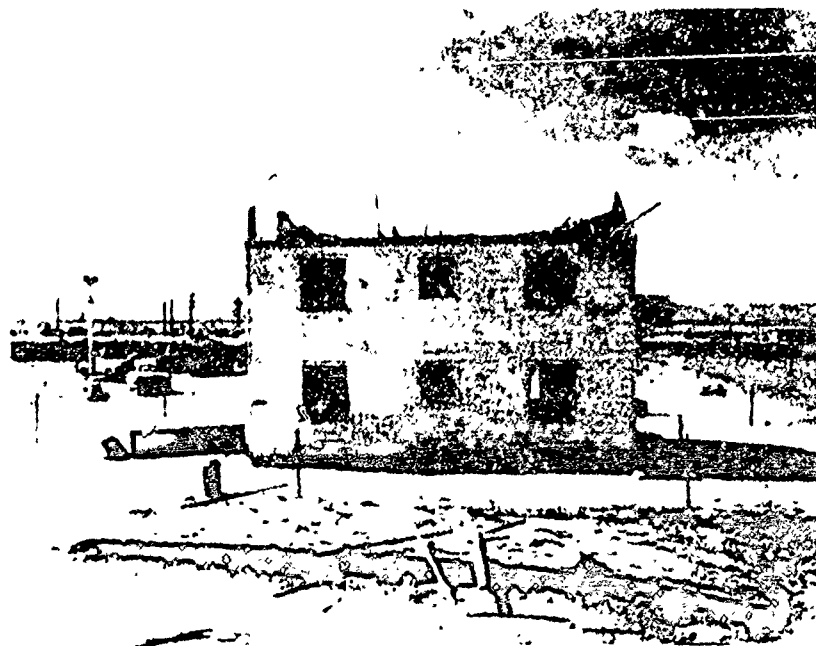
Fig. 2-22. Post-Shot Photos of House 1-3

This house was located 5500 ft from ground zero where the incident peak overpressure was approximately 4 psi. The superstructure of the house suffered severe damage, as can be seen in Fig. 2-22. The blast broke the rafters of the roof at midspan, and flattened the entire front section, with the sheathing and roofing attached, down against the ceiling joists. Most of the 2- by 10-in. rafters were split lengthwise. The rear half of the roof was lifted from the house and was dropped to the ground 25 ft to the rear of the house with the sheathing and most of the shingles attached.

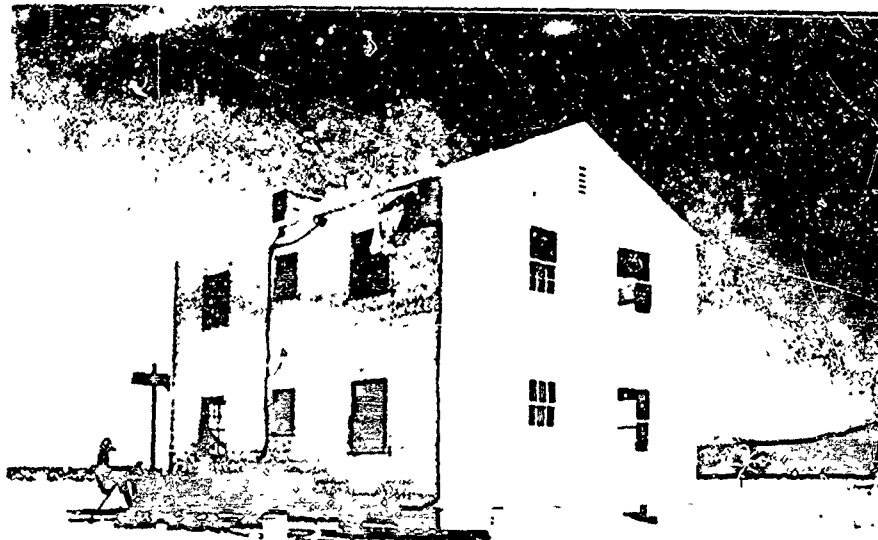
Fig. 2-33. Back and Left Side of House I-6

Although somewhat more severe, damage to the house followed a pattern similar to that seen after the first test. Damage to the windows was slightly more extensive, and a shutter at the upper-left window was torn loose, whereas no shutters were torn loose by the first test. Figure 2-33, a photograph

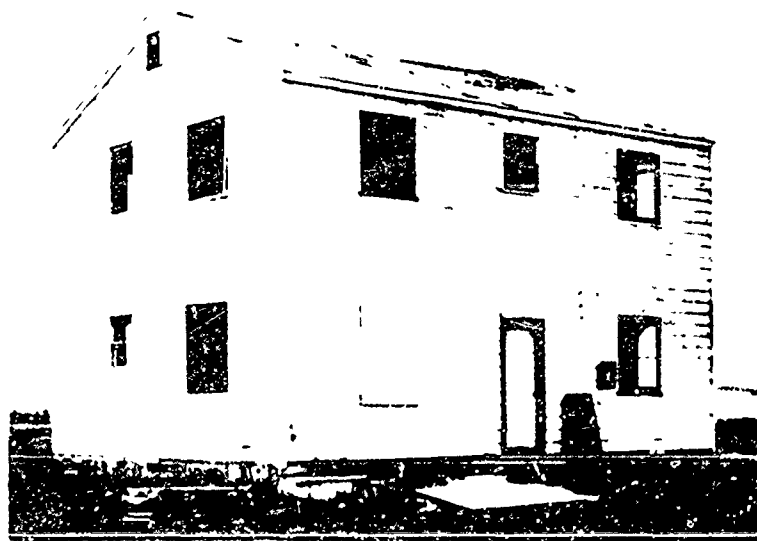
Fig. 2-59. House Exterior, East and South Side of House I-9

East Wall Some siding damage was noted at the corner of each window (see Fig. 2-59).
